Career Captain Sustains Injuries at a 2-1/2 Story Apartment Fire then Dies at Hospital – Illinois

A summary of a NIOSH fire fighter fatality investigation

September 24, 2013

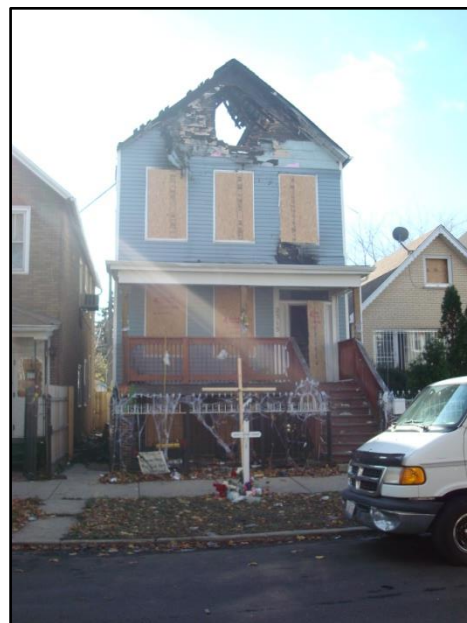
**Front view of the fire structure
(NIOSH Photo)**

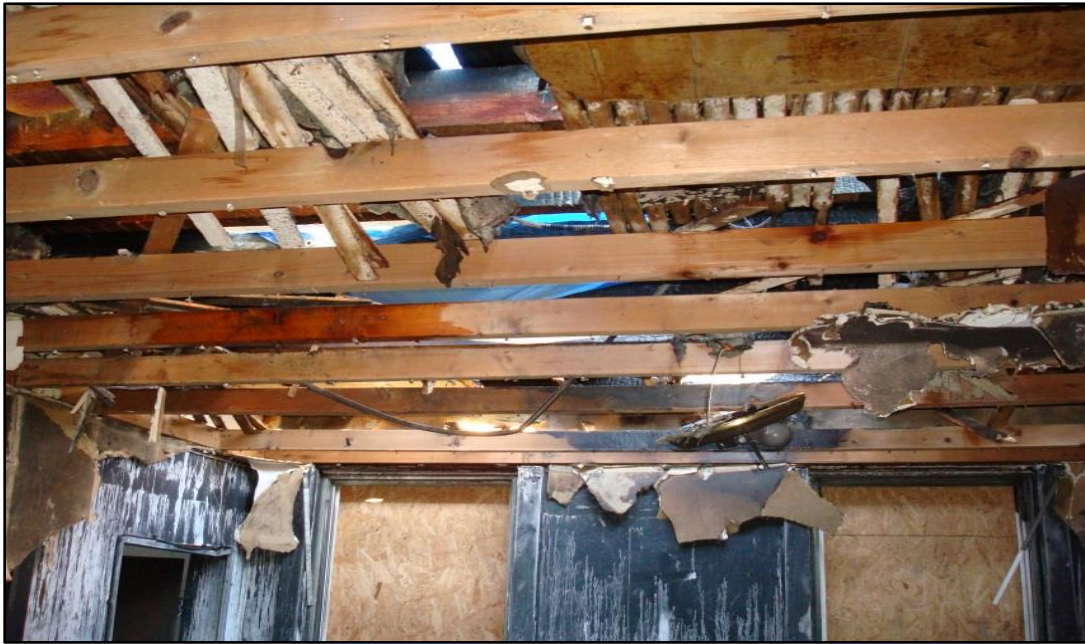
Photo 1. Second floor ceiling has multiple layers – drywall, 2 x 4 joists, lathe (subflooring), and 2 x 6 joists covered by OSB.
(NIOSH Photo)

Recommendation #9: Municipalities, building code officials, and authorities having jurisdiction should consider requiring apartment complexes and associated multiple-family dwellings that have been "retrofitted" into current structural building code requirements also be brought up to current codes for such things as sprinkler systems and adequate structural roof members when requests for permits are made.

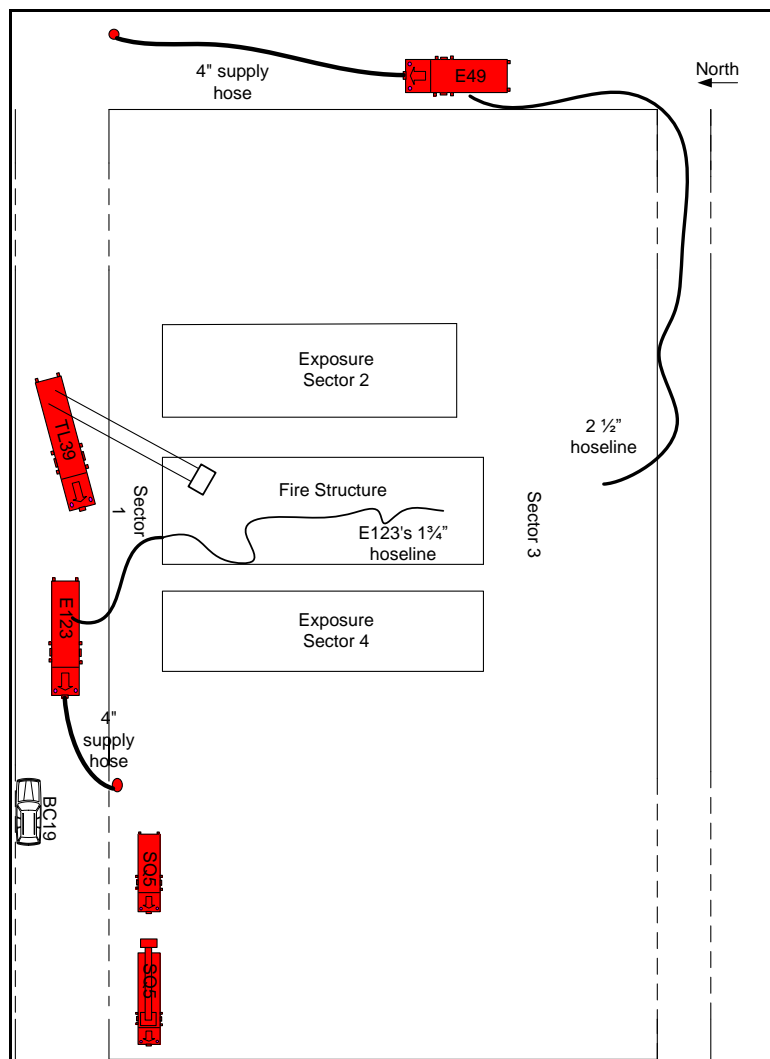
Diagram 1. Apparatus and hoseline placement

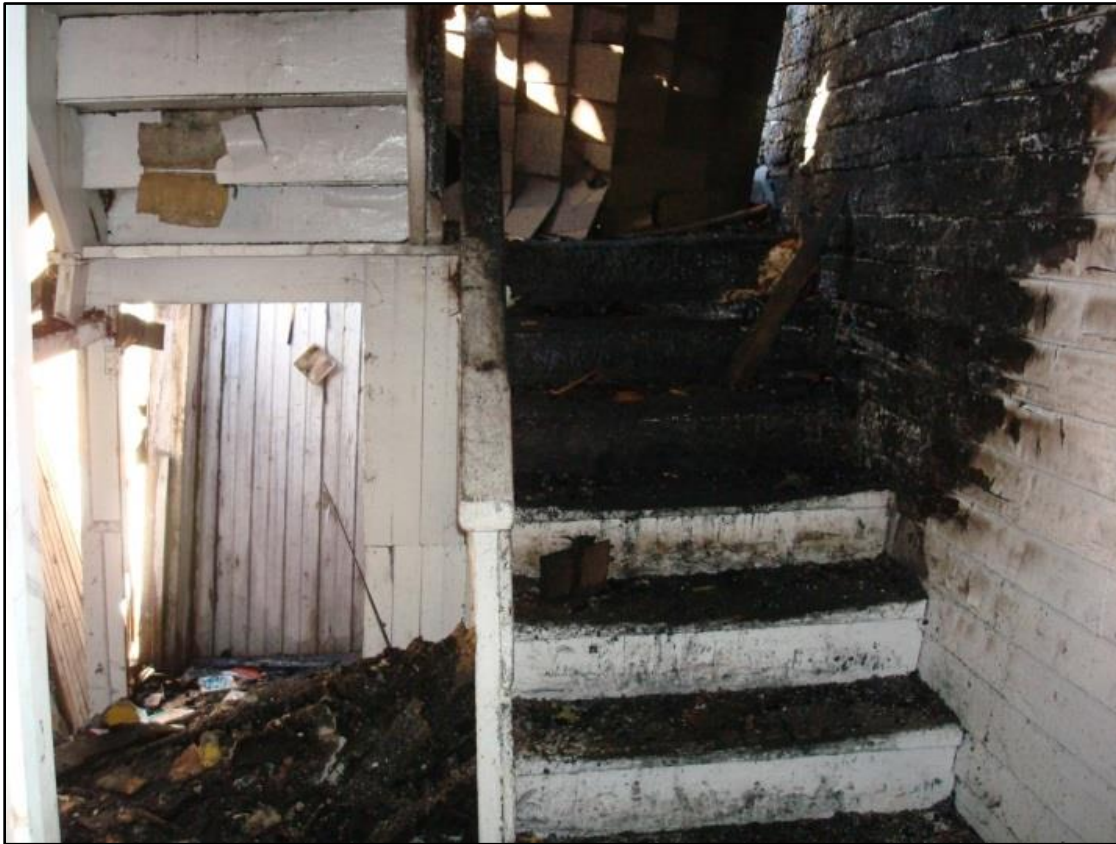
Photo 2. Covered porch and stairwell of Sector 3 from 1st floor apartment.
(NIOSH Photo)

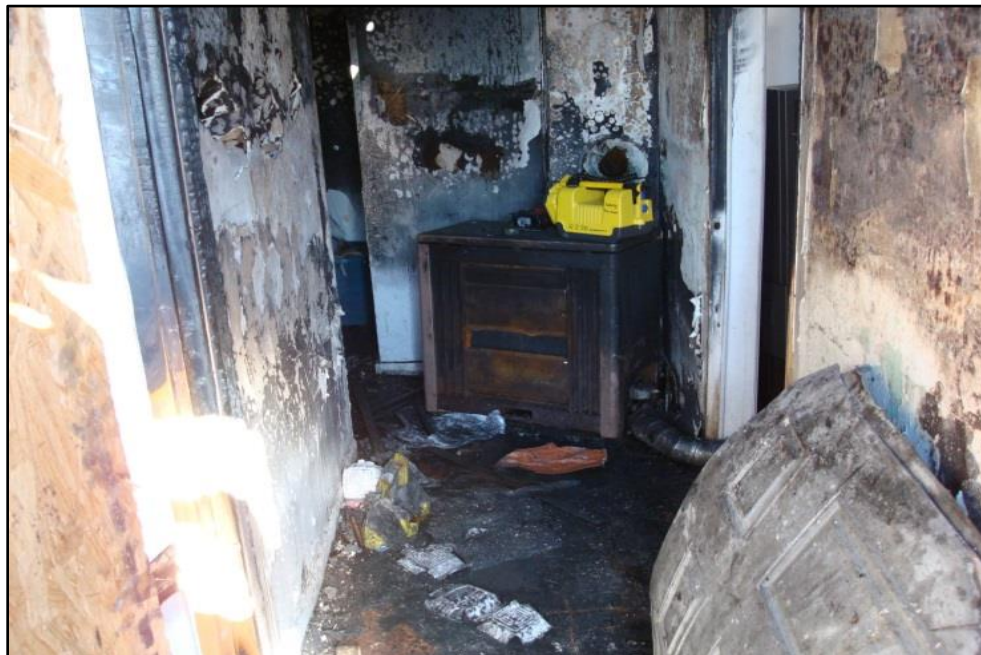
Photo 3. Hallway in which victim was operating prior to incident. Note the space heater that the victim was near when he yelled for help and the metal door that had been attached to the doorway in Photo 4 to the covered porch and was warped by the heat.

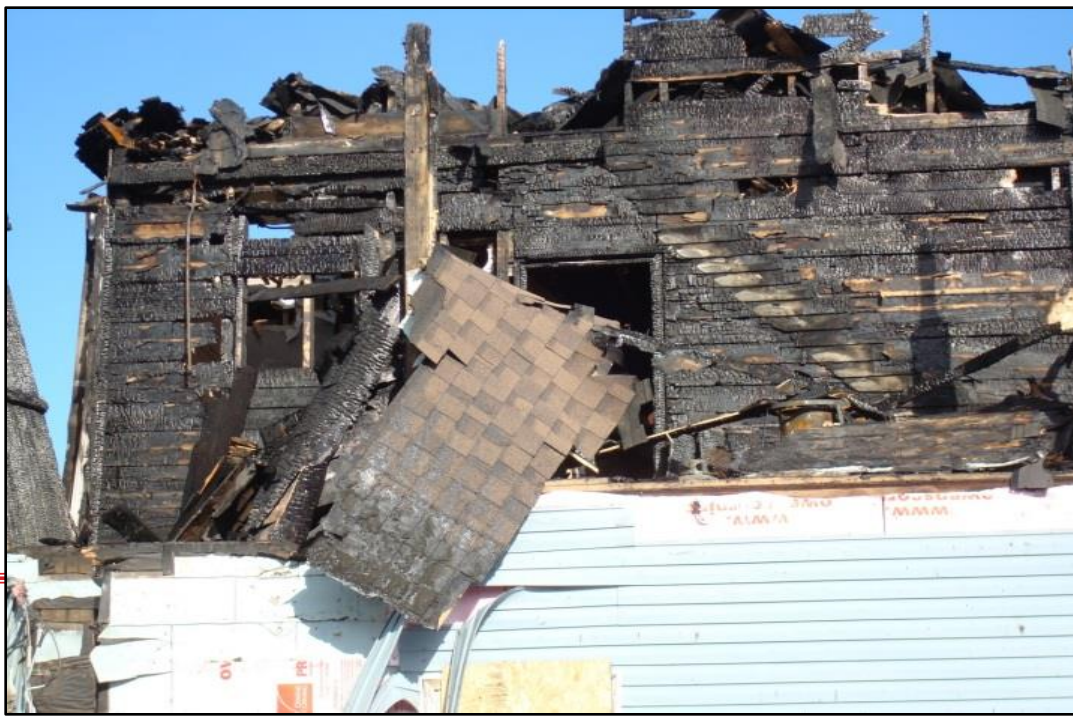
**Photo 4. Second floor doorway to covered porch, in which, the victim was operating behind
(NIOSH Photo)**

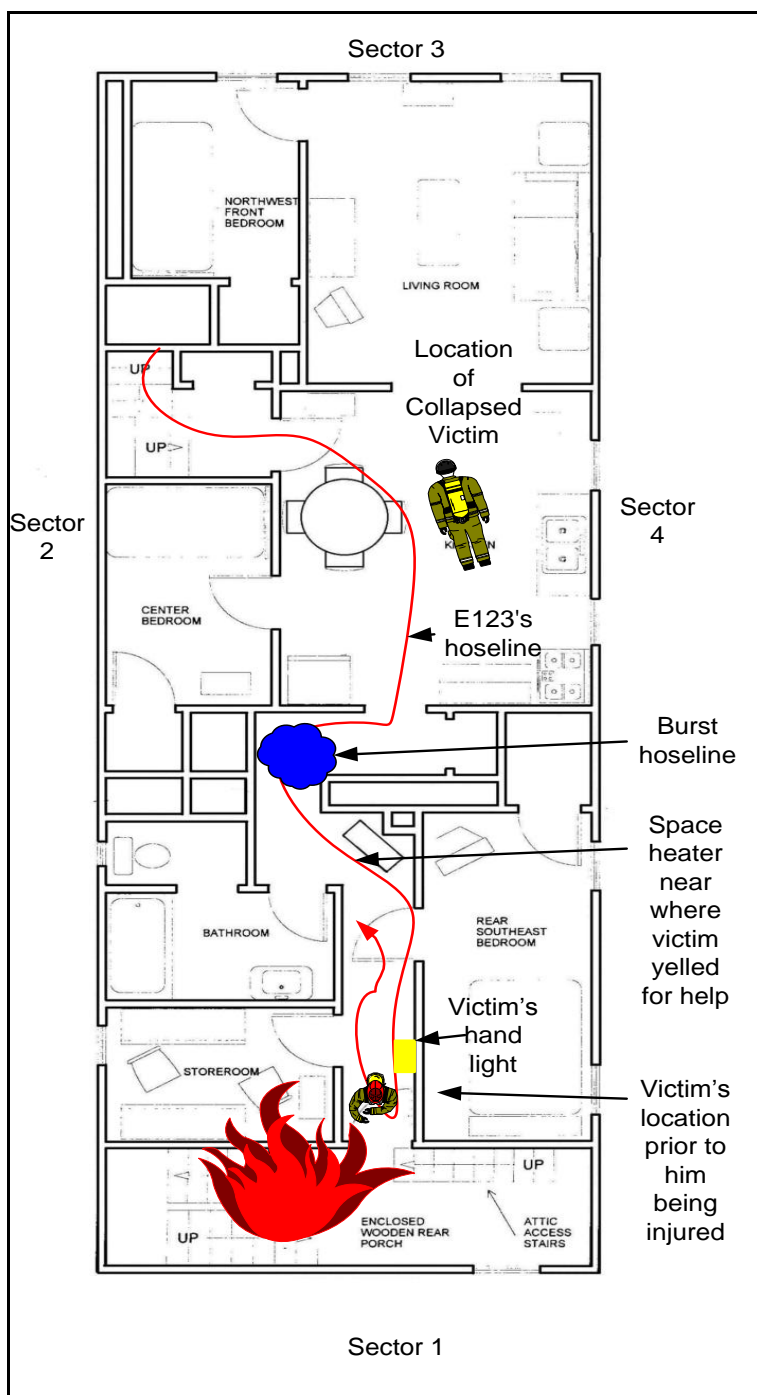
Diagram 2. Location of Victim and hoseline when found.
